Manhole Inspection Summary

Manhole # S27E__068MH

Insp Date: **9/19/07 11:22 AM**

Location Address: **205 FREMONT AVE**

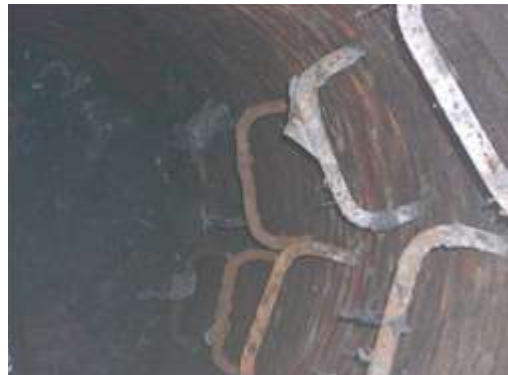
Defect 3

Steps Count: **9** Missing: **0** ☒ **Corroded**

Surcharge ☒ **Evidence Of Surcharge** Depth: **5** (ft.) ☐ Active Surcharge Present

CORRODED STEPS, EVIDENCE OF SURCHARGE ON STEPS

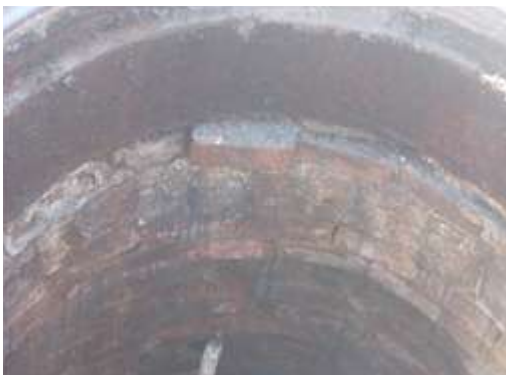
Defect 2

Condition: ☐ Sound ☐ Cracked ☐ Root Intrusion ☒ **Loose Brick** ☒ **Deteriorated**

LOOSE CHIMNEY BRICKS

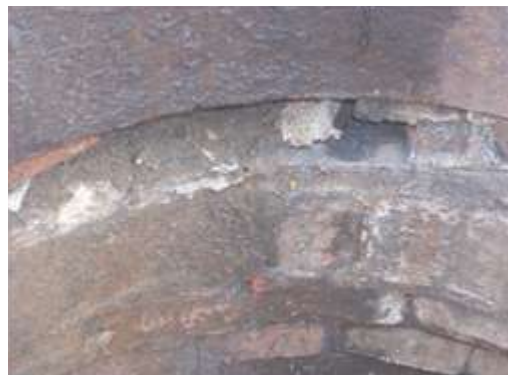
Defect 1

DETERIORATION OF CHIMNEY

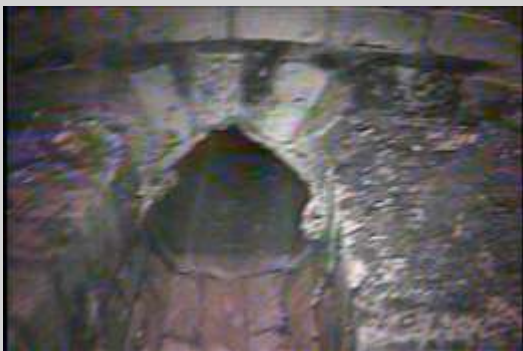
6 O'Clock Inflow

Pipe Height: **8.4** (in.) Rod and Bar (Angled)
Pipe Material: **Clay** ☐ Pipe Lined
Invert Depth: **15.44** (ft.) Flow Characteristics: **Slow**
Deposits: ☒ None ☐ Mud ☐ Sludge ☐ Debris ☐ Grease
Silt Depth: (in.) Deposits Extent:
Infiltration: **None** Pipe Seal Cond: **Broken**
